# Situation Photo Log

Tuesday, March 6, 2012

Kalamazoo River / Enbridge Spill

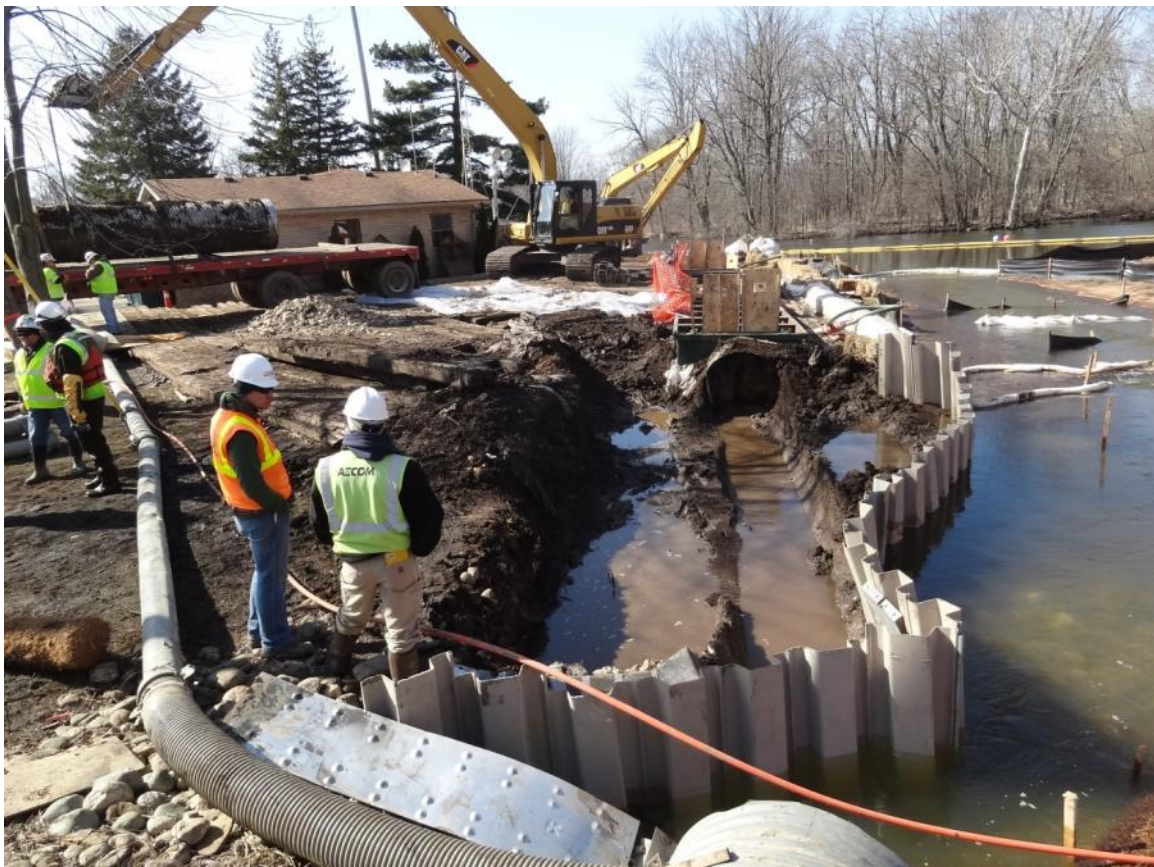
24. Confluence: observed removal of the diversion structure.

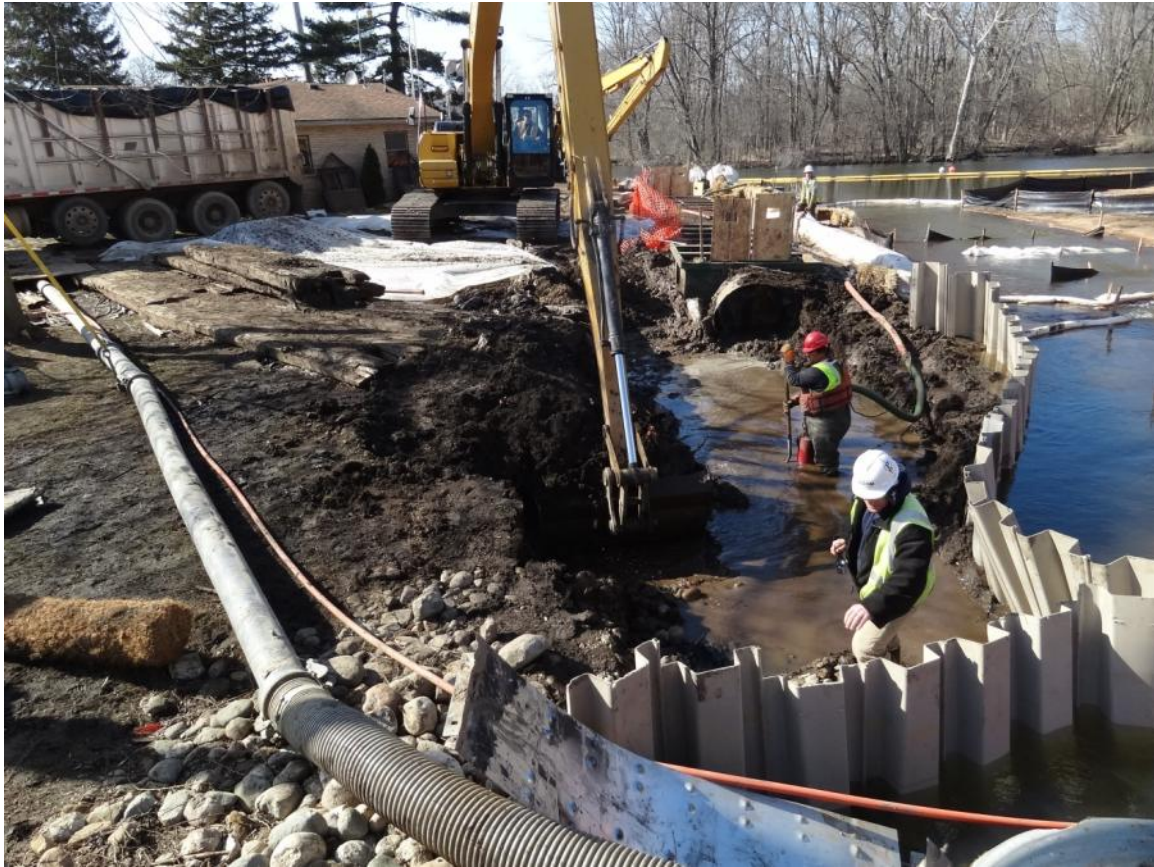
25. Confluence: observed removal of the diversion structure.

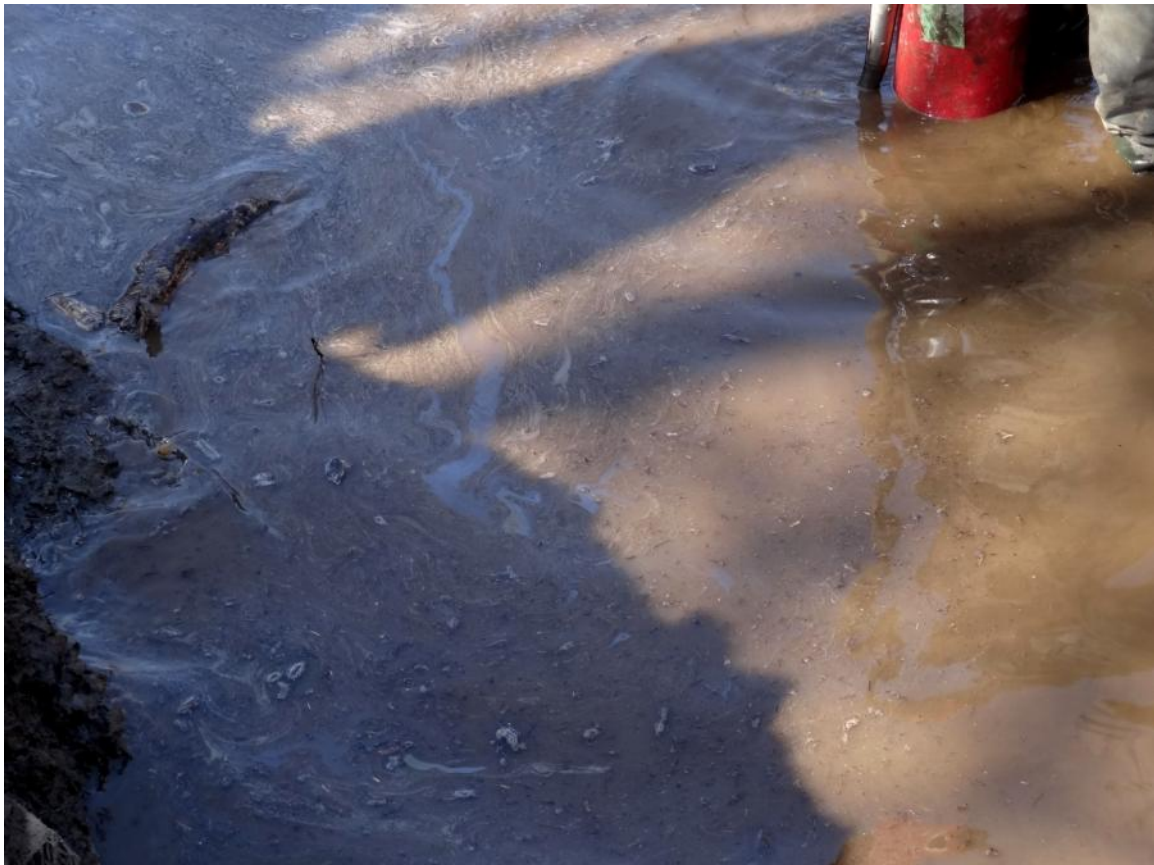
26. Confluence: sheen observed during the removal of the diversion structure.

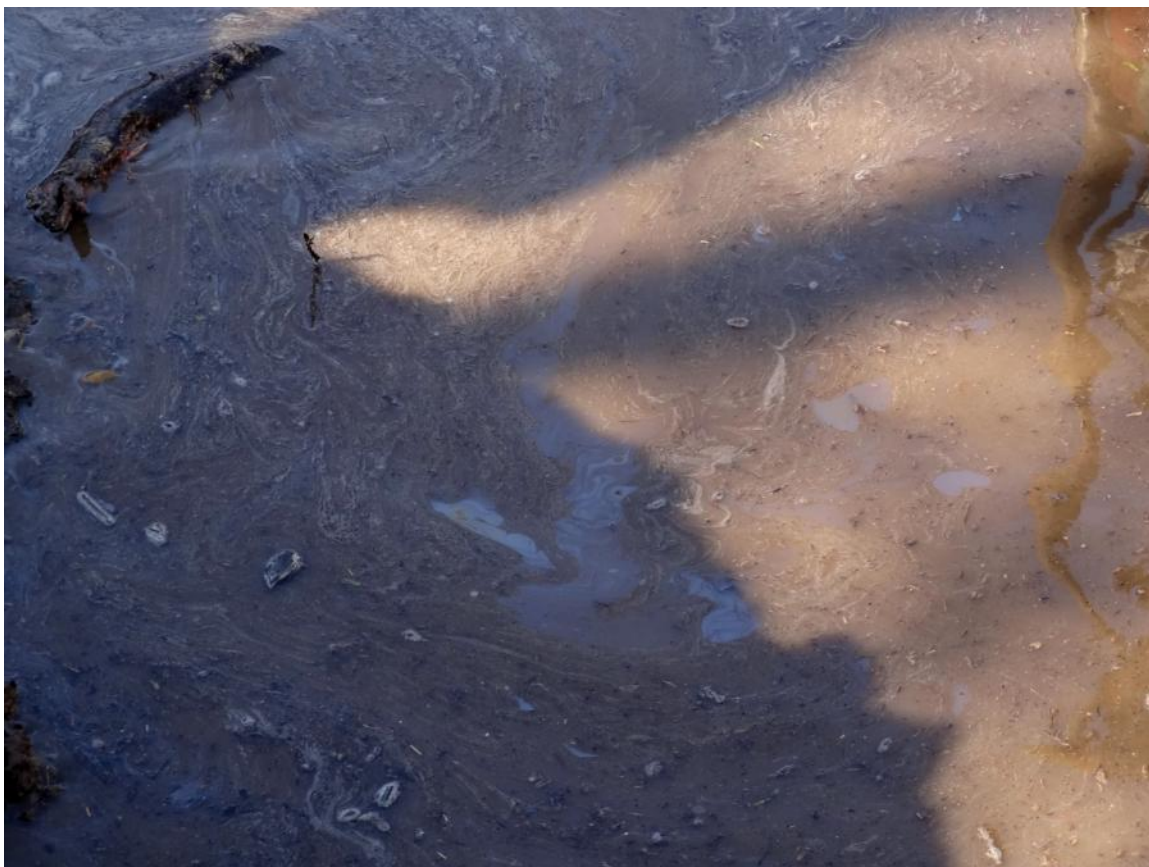
27. Confluence: sheen observed during the removal of the diversion structure.

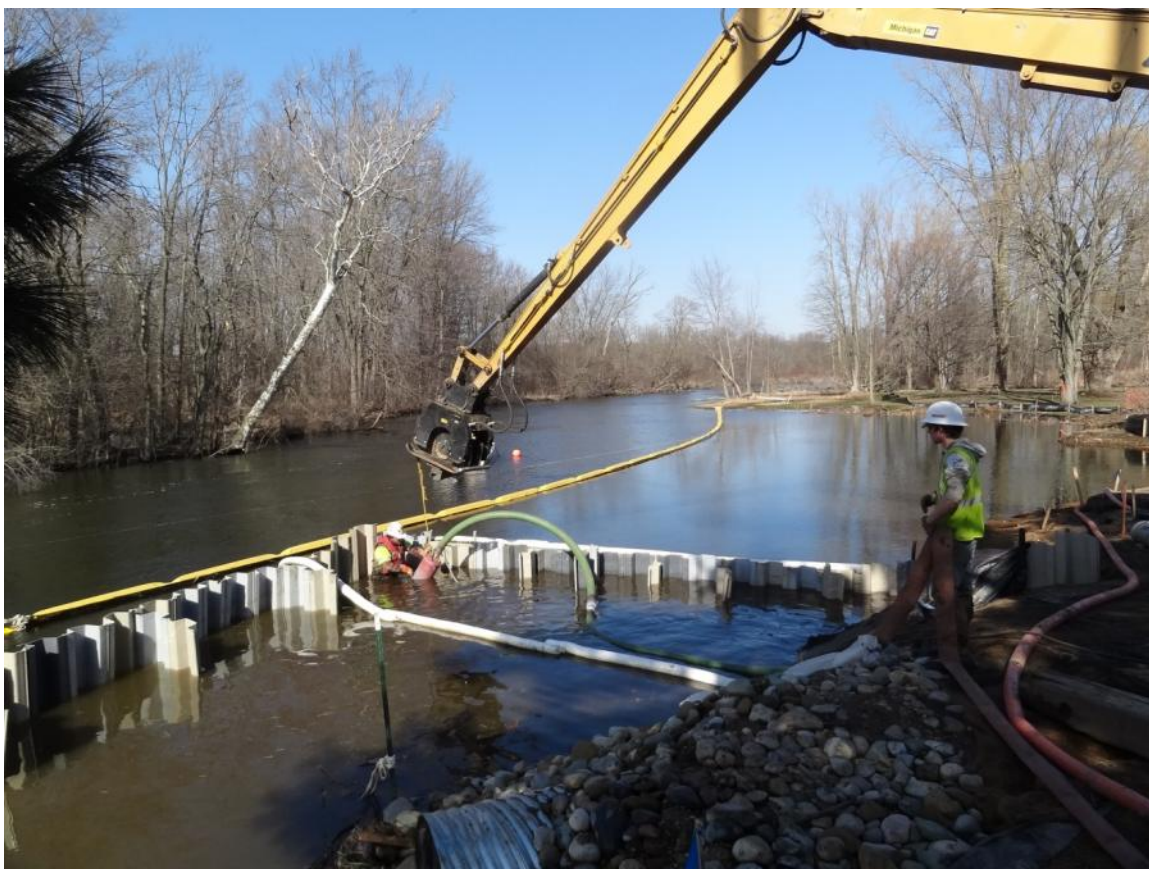
28. Confluence: observed dewatering at diversion structure discharge.

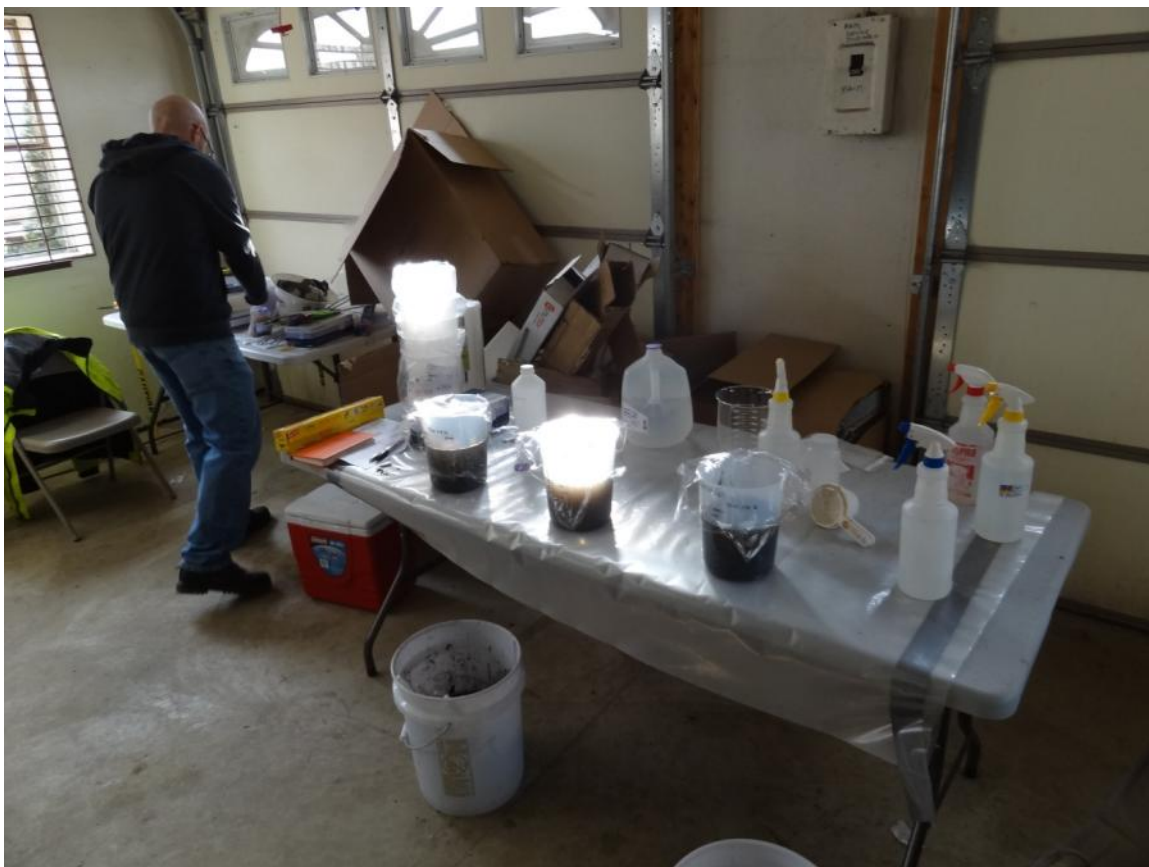
29. Temperature effects study.

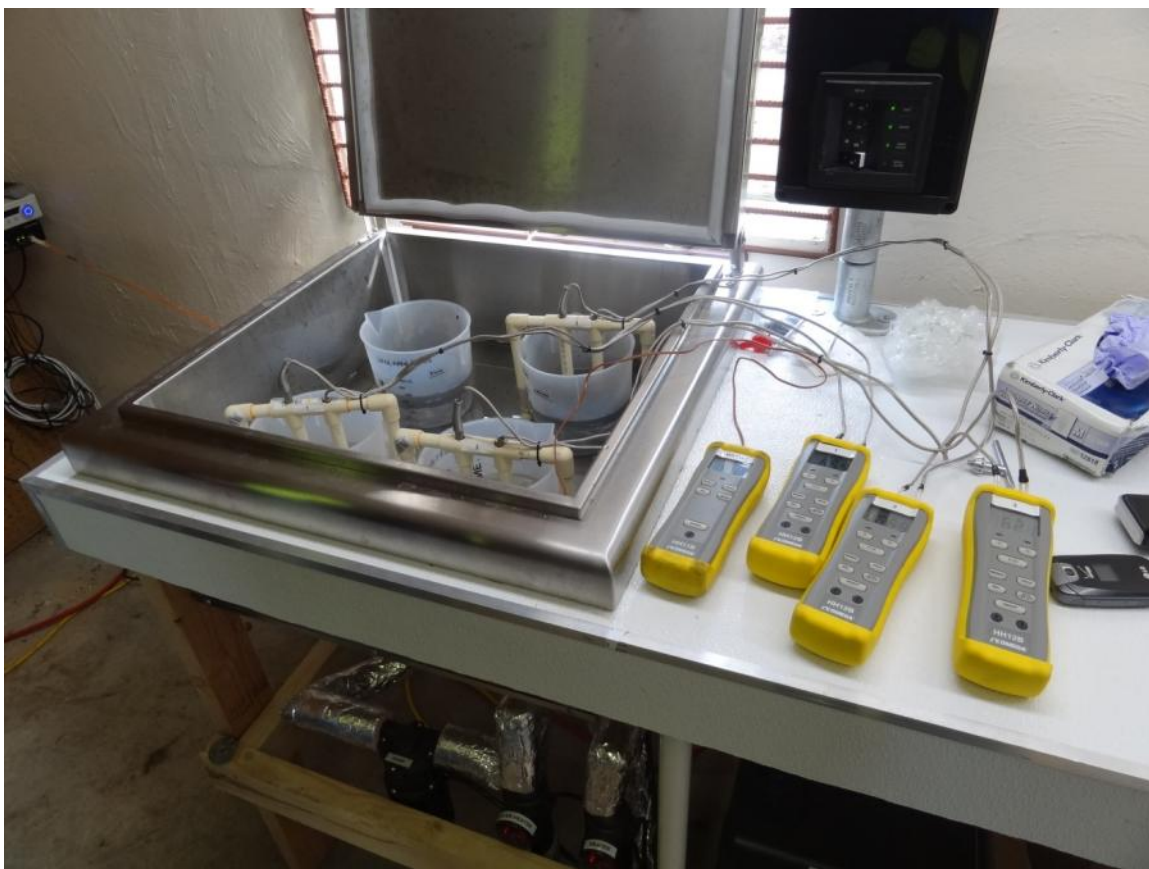
30. Temperature effects study.

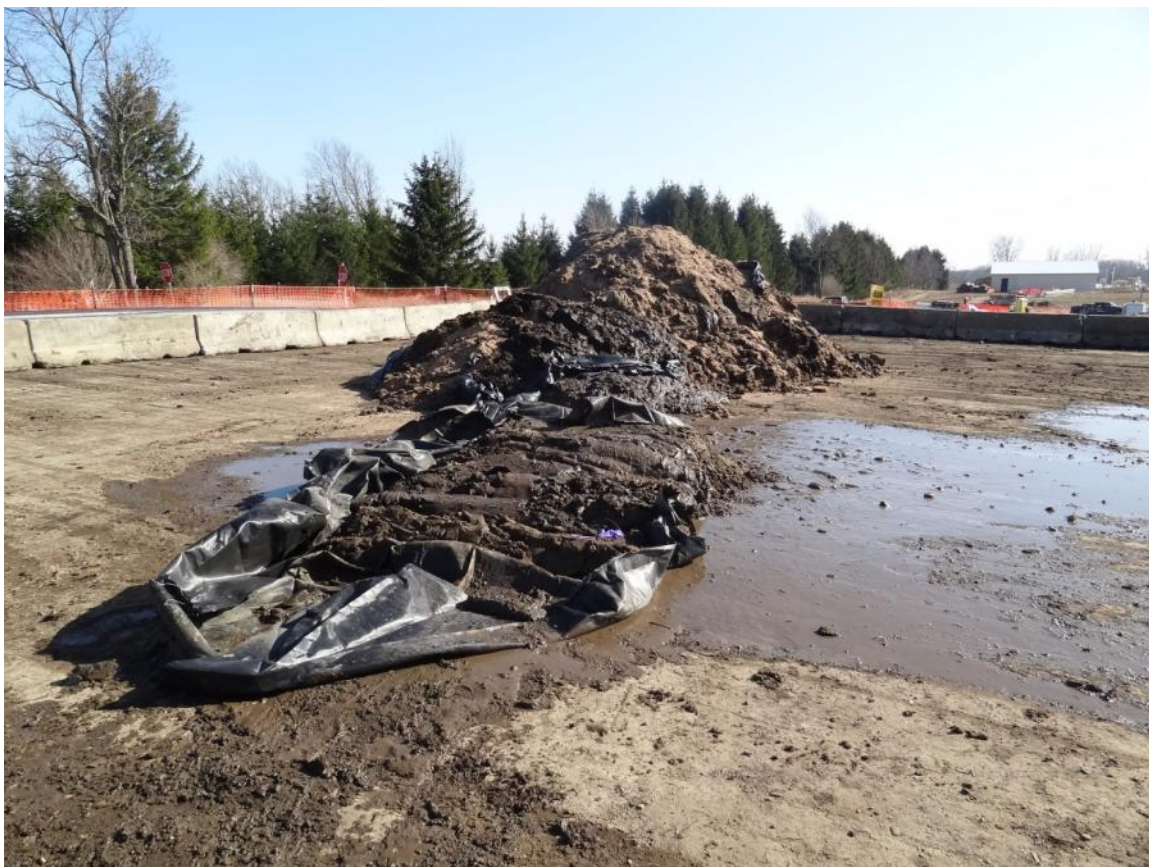
31. Frac-City vac-truck roll off emptied in to Cell A.

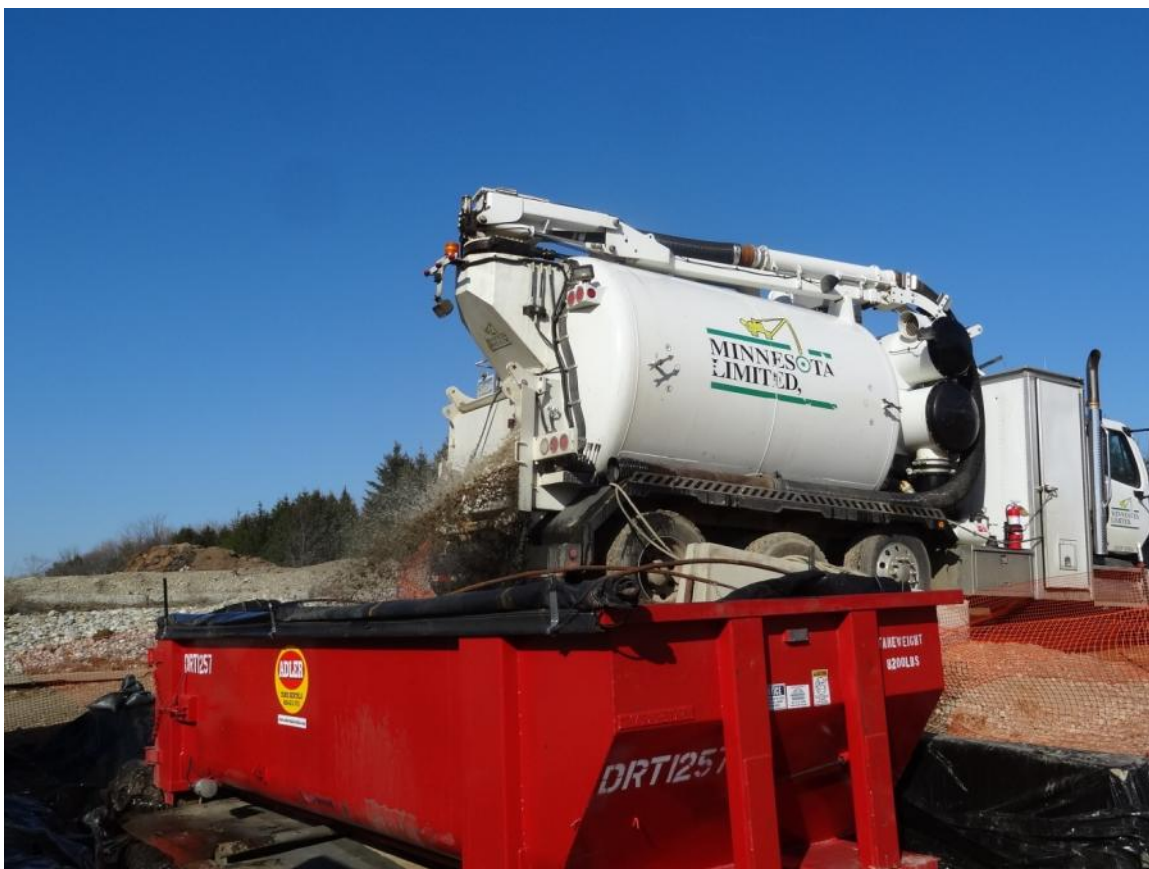
32. Vac-Truck offloading GAC contents.

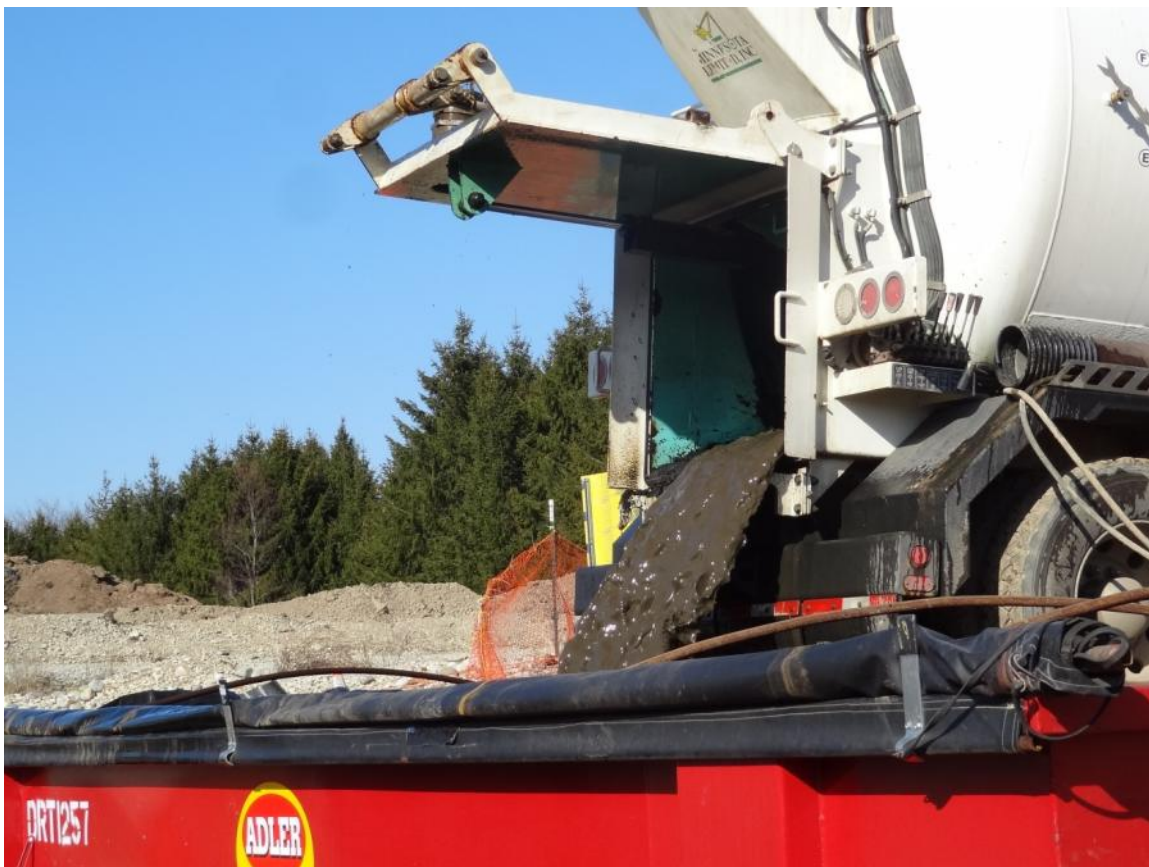
33. Vac-Truck offloading GAC contents.

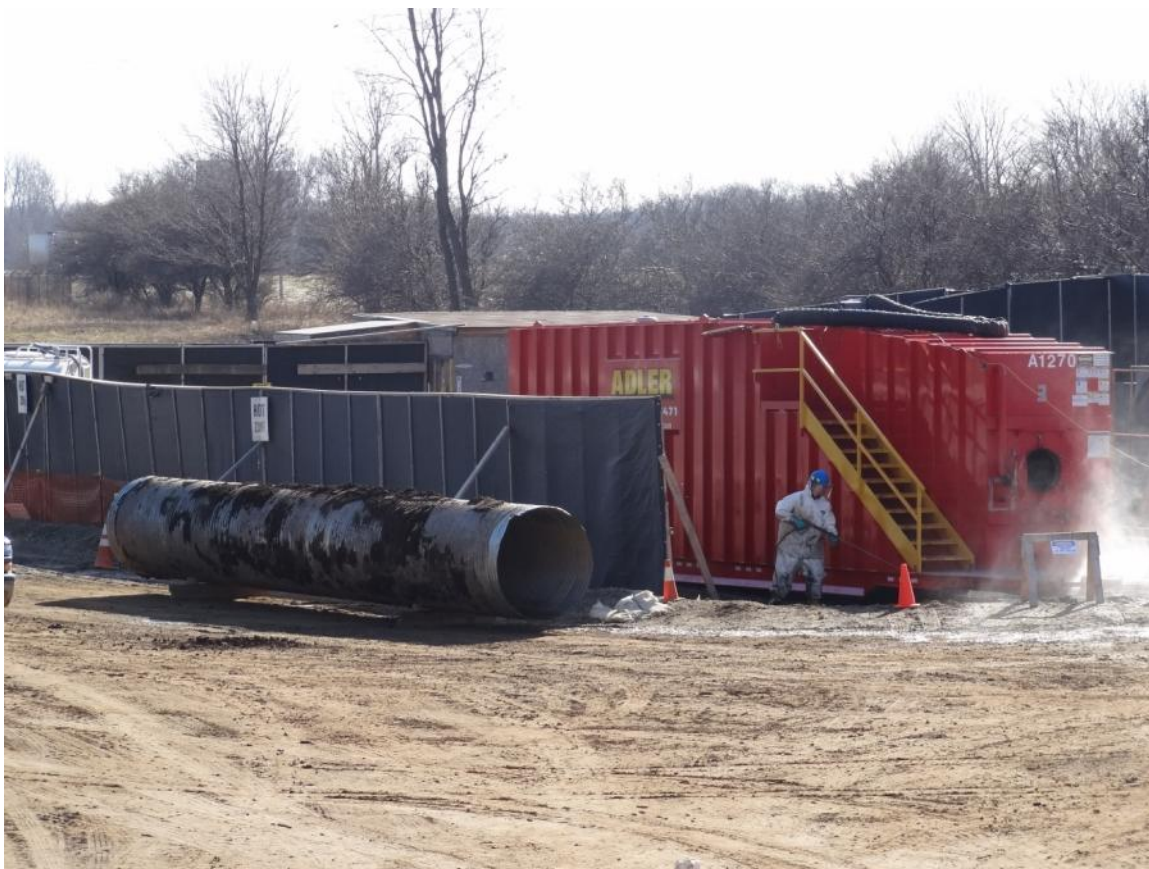
34. Frac-City observed frac-tank being decontaminated.
